EXPANDED SITE INSPECTION FINAL REPORT

**DENTON AVENUE LANDFILL
NEW HYDE PARK
NASSAU COUNTY, NEW YORK
EPA ID NO.: NY981186919**

Volume II

May 19, 1995

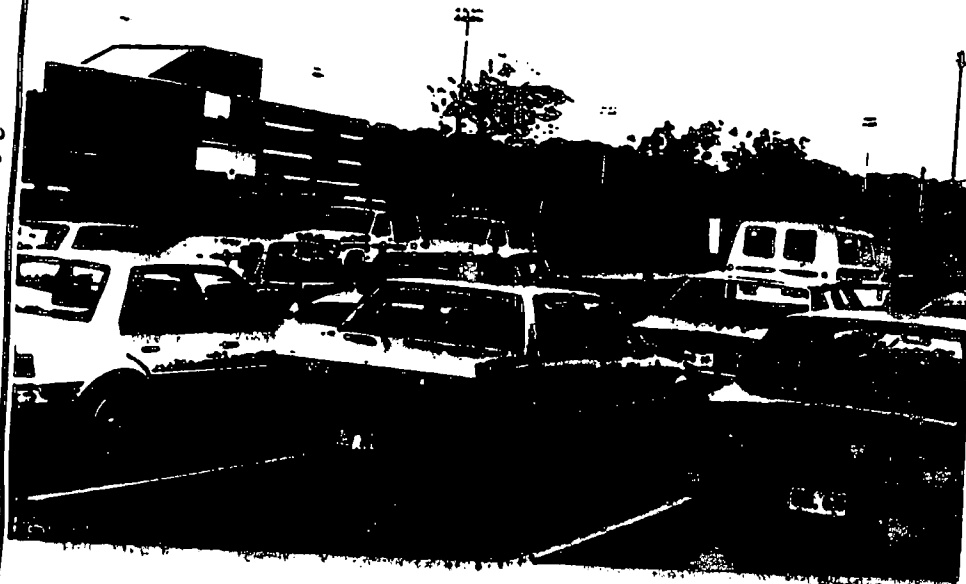
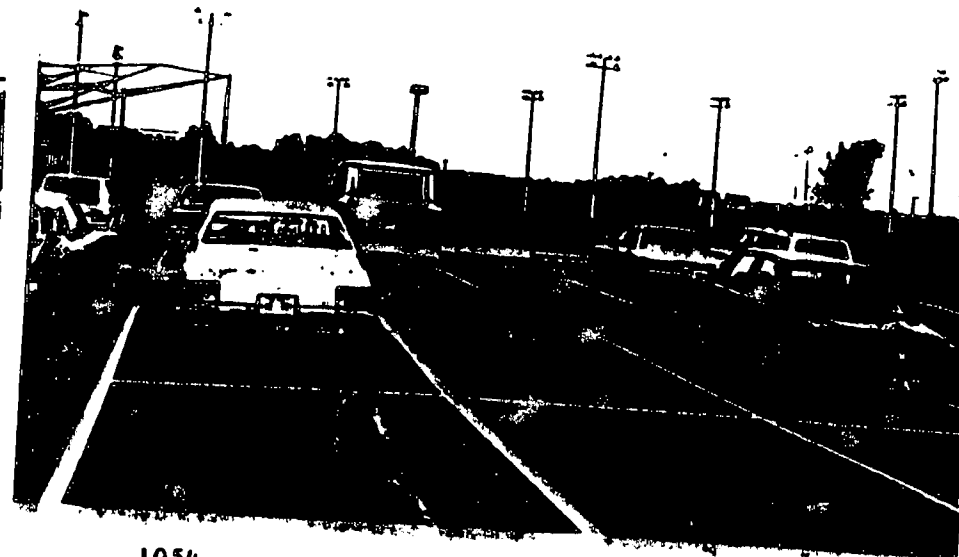
IP-7,8

June 6, 1989
Panoramic view of southern landfill as
seen from the parking lot.
